Contractor Report ARAET-CR-05002

ELECTRO-SPARK DEPOSITED COATINGS FOR REPLACEMENT OF CHROME PLATING

R. N. Johnson
J. A. Bailey
Pacific Northwest National Laboratory
902 Battelle Boulevard
P.O. Box 999
Richland, WA 99352

June 2005

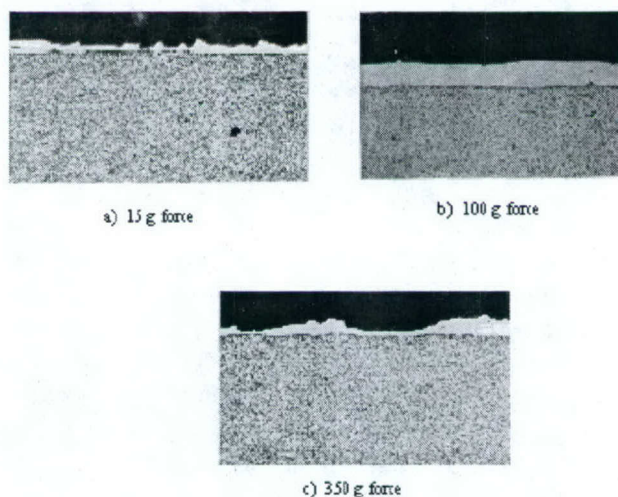
Figure 1
Effect of contact force variations on ESD coating quality (Stellite 6 on 4340 steel)

From these experiments, the optimum parameters were selected as well as the parameter most important for NLOS depositions. The most difficult to control for NLOS depositions, and one of the most important variables, was the contact force of the electrode against the substrate. A skilled operator can vary the contact force as necessary to maintain a good quality deposit, providing he can observe or sense the arc characteristics. This is obviously difficult in NLOS situations. All other parameters, though important, can be set independently of the operator's ability to observe the process. Figure 1 shows the effect of varying contact force on quality of the coating. Figure 2 shows effect of the contact force on the deposition rate

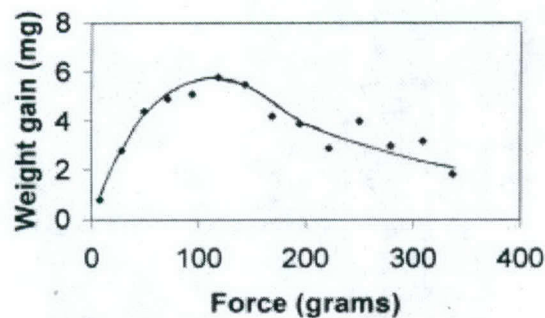
Figure 2
Effect of electrode contact force on weight gain of equal area steel coupons during ESD coating with Stellite 6

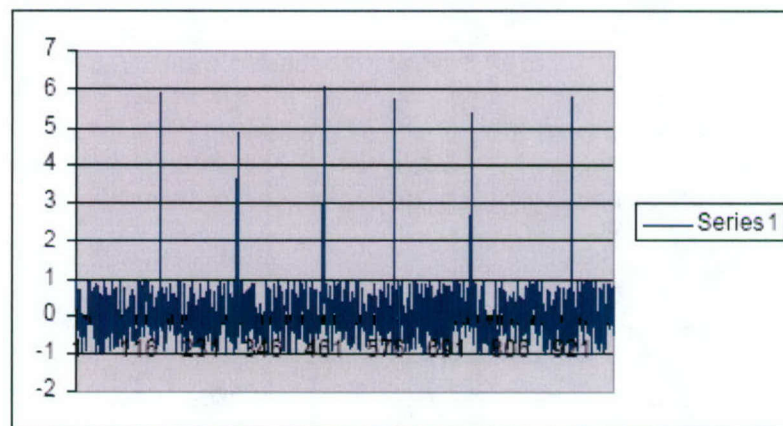
Figure 3
Wave-form traces showing peak currents associated with sparking events

The process as developed is to record enough time to capture five current peaks based on the pulse rate of the power supply, as shown in figure 3. Then discriminate the highest peak value in the sample. This current is normalized to have the same range as the current setting on the pulse generator. That is, a 50% value on the detected peaks has the same range as 50% on the control setting. The peak value is compared to the set point on the controlling computer user interface. A lower or higher value (never an equal value) results in the movement of the Z-axis motor to correct the probe pressure.

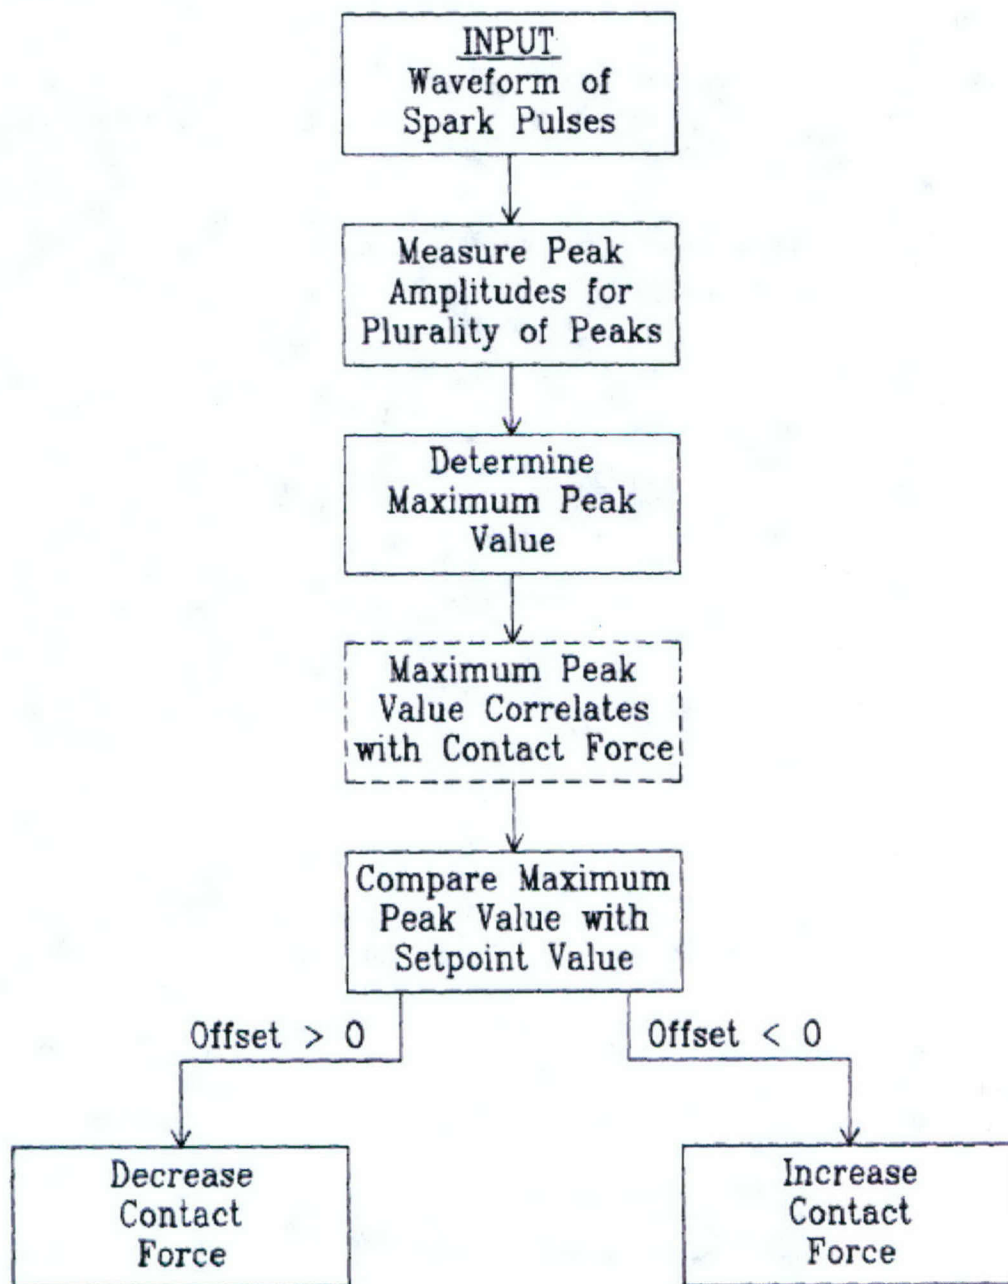
Figure 4
Flow diagram of force control process for ESD coatings

Once it was proven that the scheme would work with the raster application on a flat coupon sample, the planned improvements on the mechanical control system were discarded. The new electronic feedback scheme was conspicuously more accurate. An operating application was controlled to within 5 g of 100 g electronically. A flow diagram for the process is shown in figure 4.

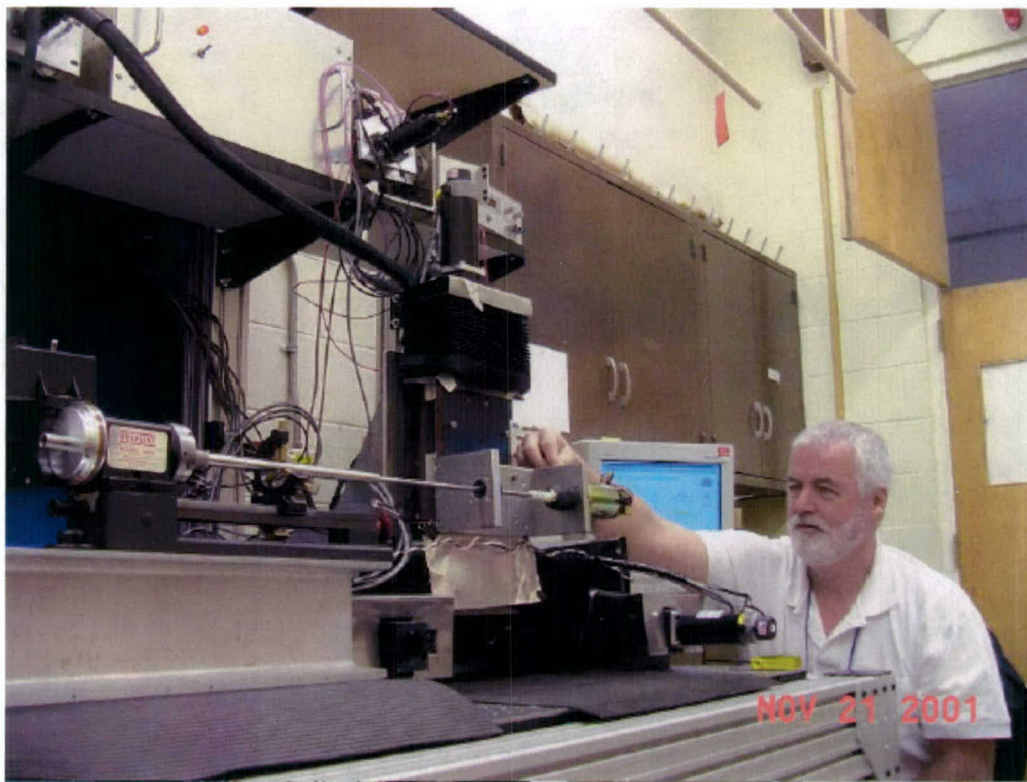
Figure 5
Set up for automated ESD coating of inside diameters of tubes

The electronic control system was alternately worked to apply it to flat surfaces, outside tubing surfaces, inside tubing surfaces, and the hand-held applicator. The software was written such that any of the processes would work in any orientation. Since the electronic control was independent of gravity, it could be applied in any direction (or in a gravity free environment.) A coating can be applied from the left, right, up, or down positions. Coatings were applied to inside diameters of steel tubes as small as 0.30 in. A set-up for automated coating of inside diameters of tubes is shown in figure 5.

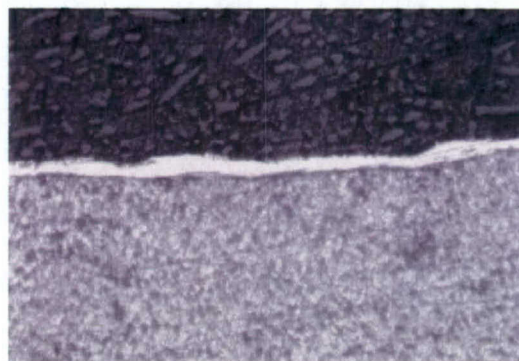
Figure 6
Example of Stellite 21 applied to inner diameter of 0.30 in. steel tube

The process for flat surface application using the three-stage platform was perfected. Also Perfected was the process for manual application. There is an operating hand-held applicator that has an audio feedback to the operator that is in the bench stage and needs only cosmetic changes. A few refinements must be added, such as variable frequencies of high and low feed-back. (Some operators might be deaf to some operating tones.) The apparatus for ESD on an inside tube surface was demonstrated. (Figure 6 shows an example of Stellite 21 applied to the inside diameter of a 0.30 in. steel tube.) A patent has been filed on the development.

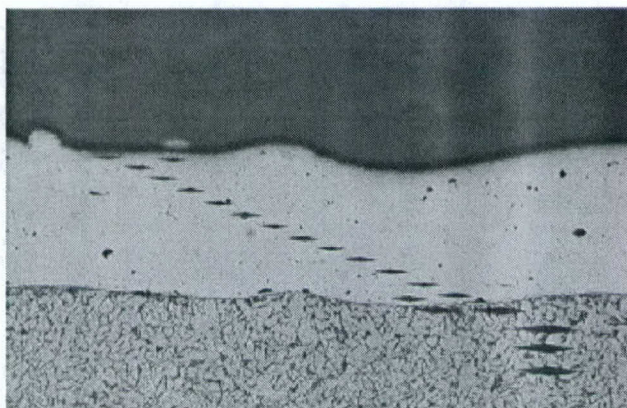
Figure 7
Microstructure of Stellite 6 ESD deposit, 75 µm thick, on steel showing hardness test indents
Note the absence of a detectable heat-affected-zone.

ESD coatings typically are harder than the electrode from which they are deposited. This is attributed to the exceptionally fine grain size and homogeneity of the deposits, and to the Hall-Petch effect (where hardness increases with decreasing grain size). Figure 7 shows a typical micrograph of a hardness profile obtained in these studies. In ordinary weld deposits, Stellite 6 normally exhibits a hardness of about 400 Knoop (40 Rc), but ESD deposits of Stellite 6 exceed 700 Knoop (58 Rc). Likewise, Stellite 21 normally shows a hardness of 290 Knoop (27 Rc), but in the ESD deposit, averages 613 Knoop (54 Rc). For comparison, Electrolytic Hard Chrome (EHC) usually measures between 600 and 1100 Knoop.

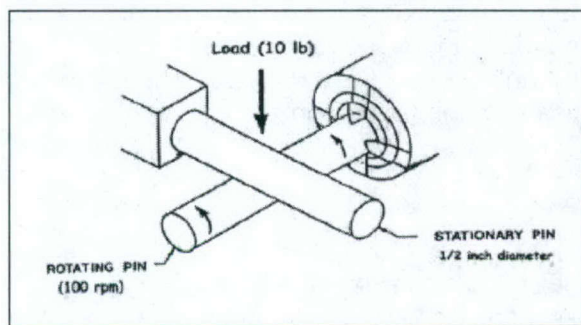
Figure 8
Crossed cylinder wear tester, ASTM G83

A modified ASTM G83-83 crossed cylinder test was performed to evaluate the resistance of the coatings in metal-to-metal or adhesive wear. Figure 8 shows a schematic of this testing apparatus. A 1/2-in. diameter cylinder was rotated at 100 cycles per minute while a load of 10 lbs forced it against a stationary cylinder. The rotating cylinders were the test cylinders. Four were coated with the ESD coatings, one was hard chrome plated, and one was uncoated 4340 steel. The stationary cylinder was D2 tool steel, heat treated to a hardness of HRC 60. In order to avoid penetration of the thin coatings during the prescribed 5000-cycle test, the test was interrupted every 1000 cycles, and weight loss of the rotating cylinder was measured. Each 1000 cycle portion of this test was done on a new area of the coating (and a new spot on the stationary cylinder) so that the entire wear test took place in the coating material. All five weight losses for the five 1000 cycle test portions were totaled, and divided by the specific gravity of the coating material to obtain the total volume loss for the 5000 cycle test. This total was then divided by the total sliding distance of the 5000 cycles, 199.49 m, to obtain the volume loss/meter of sliding distance value shown in figure 9. Additional wear data is provided in the appendix.

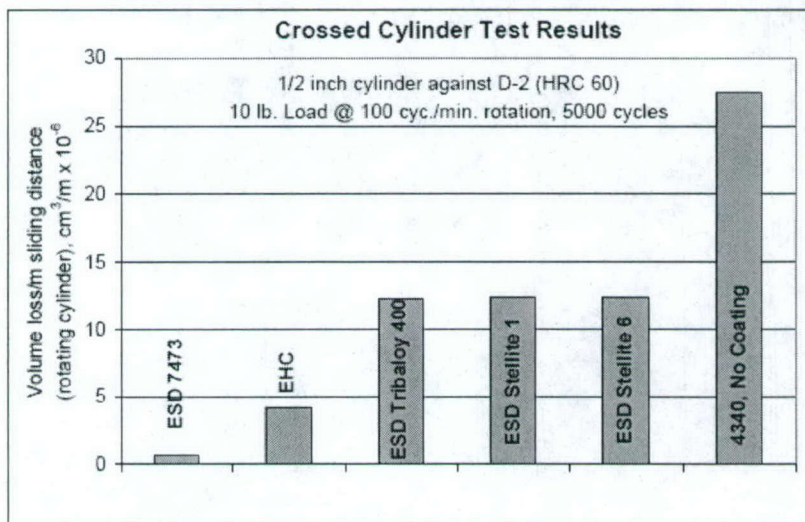
Figure 9
Results of crossed cylinder wear test (material 7473 is WC-25TaC-13Co)

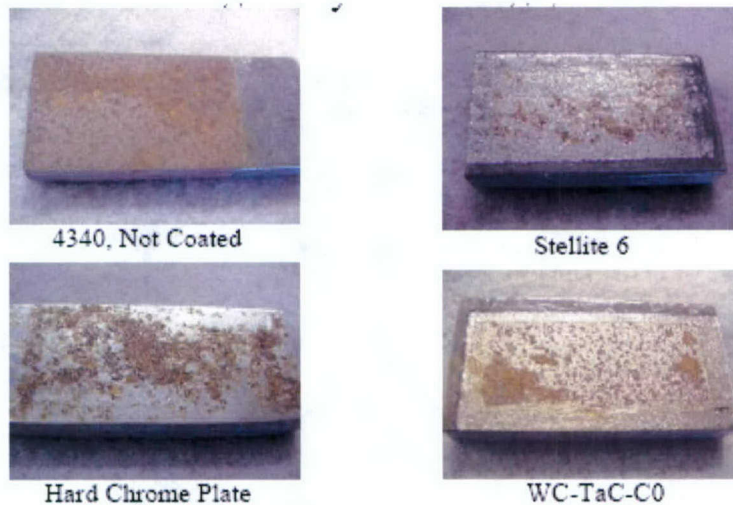
Figure 10
Results of salt fog testing (ASTM B117), 48 hrs exposure, single layer coatings

Salt fog testing in accordance with ASTM B117 was performed on ESD deposits of various coatings on 4340 steel, and on an EHC coating on 4340 steel for comparison. Single layer coatings showed similar corrosion resistance to the chrome plating, with rusting appearing after 48 hrs exposure, as shown in figure 10. Multiple layers consisting of two or more passes of the Stellites showed no signs of corrosion after 96 hrs exposure, as shown in figure 11. Additional corrosion data are shown in the appendix.

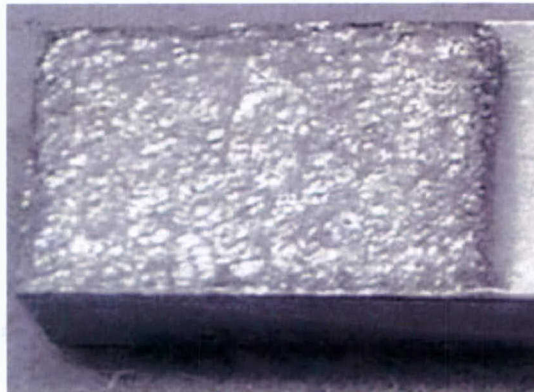
Figure 11
Stellite 21, 3-layer coating on 4340 steel, after 96 hrs exposure to salt fog (ASTM B117), showing no corrosion

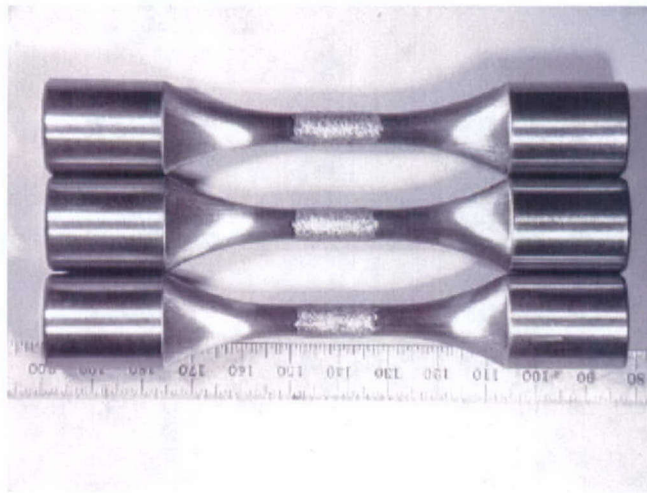
Figure 12
Fatigue bars coated with Stellite 21, before grinding and finishing

Coatings of Stellite 21 were applied to 4340 fatigue bars for tests at Wright Patterson Air Force Materials Laboratory (fig. 12). The as-deposited coatings were ground down to leave a polished layer 75 μm (3 mils) thick. Tests were conducted at 185 ksi, $R = 0.1$, 20 Hz. Results indicated that fatigue life was reduced compared to bare uncoated 4340 steel. The average cycles to failure for the uncoated steel was 141,116 cycles with a minimum of 32,879. The coated steel averaged 8,965 cycles to failure with a minimum of 8,595. A metallurgical analysis by AFML showed a major cause of the debit was a heat-affected-zone in the steel. This was the result of using high-deposition-rate parameters combined with a small specimen mass (inadequate heat sink). When the parameter optimization was completed (3 months after the fatigue specimens were coated), it was found that the HAZ would have been minimized and defects reduced by using the more optimum, moderate deposition-rate parameters identified by the Taguchi matrix.

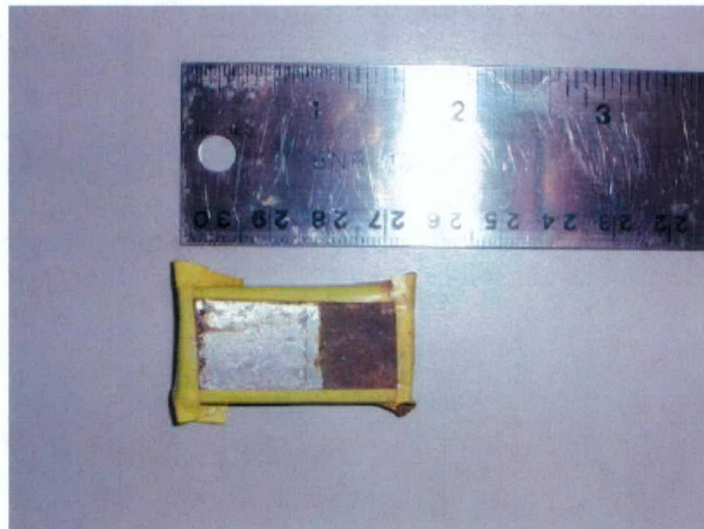
Figure A-1
ESD-coated Specimen 02-0040-P

Examples of ESD-coated and EHC-plated corrosion specimens are provided in Figure A-1 and Figure A-2, respectively. In Figure A-1, the ESD coating was applied to the left half of the facing surface. The right half is the non-coated 4340 steel surface.

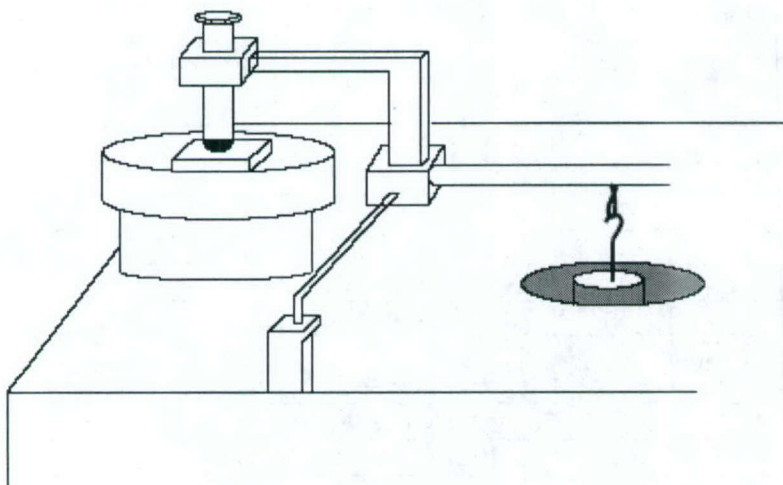
Wear resistance of the coated specimens was tested against sliding 440C stainless steel of ½ inch diameter using an ISC-200PC Tribometer, originally manufactured by Implant Sciences Corporation, as depicted in Figure 3-1 below. In this test, a stationary ball is placed on a rotating test disk for a specified length of time for a given applied load. The test ball is attached to a precision-balanced lever arm that applies both a vertical load to the ball and measures the frictional force on the ball. The test disk is held on the tribometer by a rotating vertical shaft. The friction output signal is transmitted to a PC-Stripchart™ that plots the coefficient of friction versus the time of the test or the distance that the disc has traveled.

Figure A-3
Tribometer

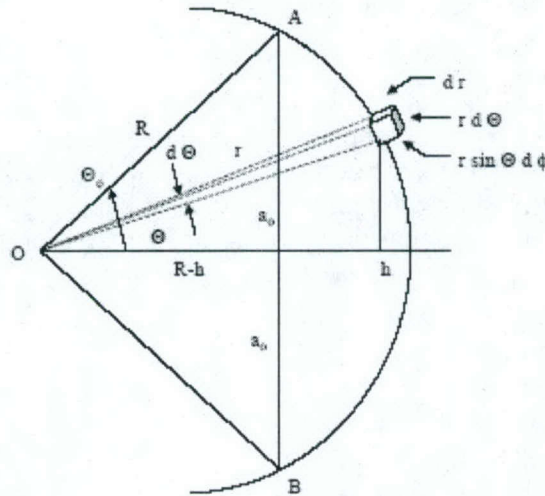
The volume of the wear scar on the 440 C stainless steel test ball is calculated using equations (2), (3), (4), and (5) to derive equation (6). In these equations, R represents the radius of the test ball used and a_0 represents the radius of the wear scar. Figures A-6 and A-7 shows the test ball and the associated dimensions.

Figure A-6
Test Ball and Dimensions

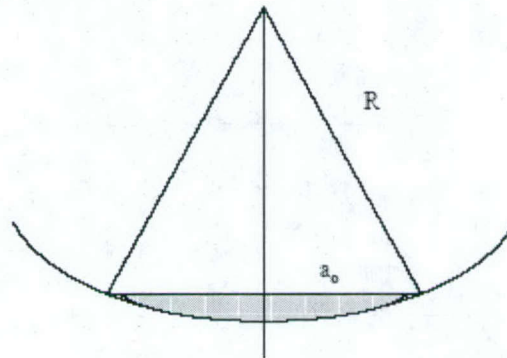
Figure A-7
Test Ball with Worn Volume Shown

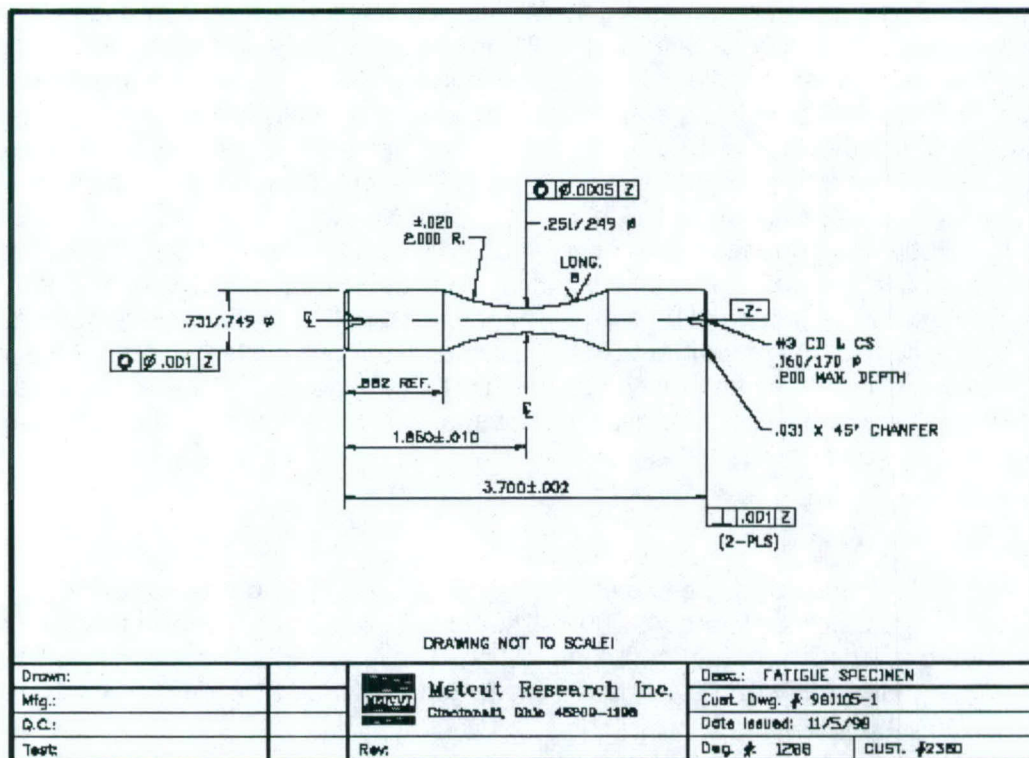
Metcut, Cincinnati, Ohio, fabricated six specimens for ESD coating per Metcut Drawing 1288 using hardened (~48-50 Rc) 4340 steel. Metcut Drawing 1288 is provided in Figure A-10. All Metcut specimens were coated by PNNL's ESD equipment using Stellite 21 with a hardness of 500 to 600 Knoop. ESD Specimens 40-13, 40-14 & 40-15 did not have a nickel underlayer and ESD specimens 40-16, 40-17 & 40-18 did have a nickel underlayer.

Figure A-10
ESD Fatigue Specimen Geometry

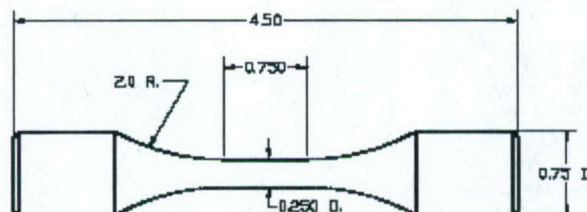
AFRL EHC fatigue specimens were machined to the configuration shown in Figure A-11. All of the coatings were applied and uniformly ground along the entire length of the specimen between the end grips to include the blend radius region.

Figure A-11
AFRL EHC Fatigue Specimen Geometry

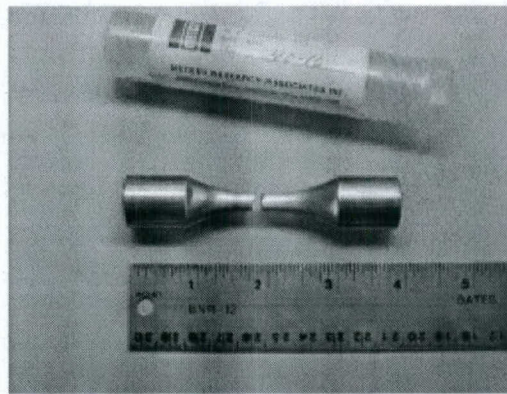
Figure A-12
Typical Fatigue Specimen

The Laboratory Report from Metcut for fatigue testing of ESD-coated specimens is provided as Attachment III. A typical fatigue specimen is shown in Figure A-12.

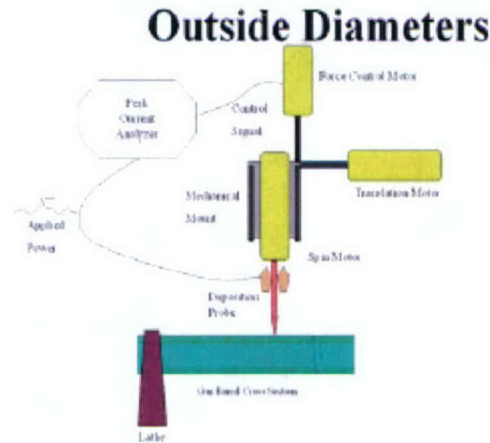
The position of the probe head is corrected and the next pulse is applied at or near the target pressure.

Although the above figure shows the simplest case of an exterior surface being coated, the principle and application are the same for automatic force control in any orientation or direction, and in non-line-of-sight or interior surface coatings.
